AEROSPACE REPORT NO.
TR-92(2935)-17

Long Duration Exposure Facility Experiment M0003 Deintegration/Findings and Impacts

M. J. MESHISHNEK, S. R. GYETVAY and C. H. JAGGERS
Mechanics and Materials Technology Center
Technology Operations

15 December 1992

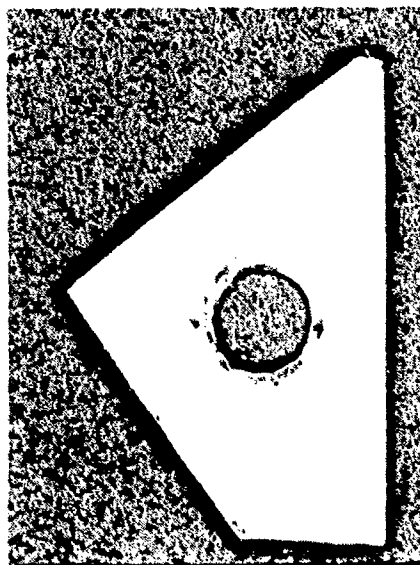
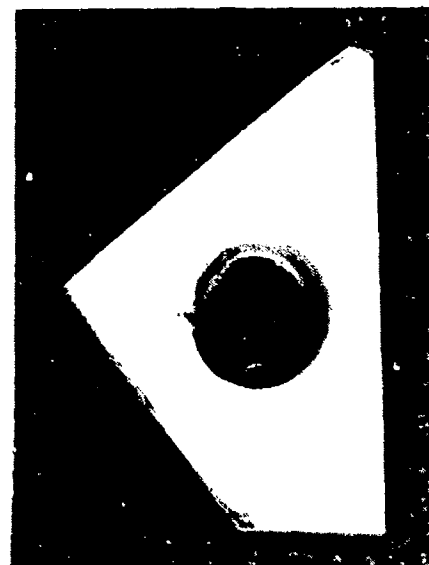
Figure 30. Response of masked Chemglaze A276 to UV radiation

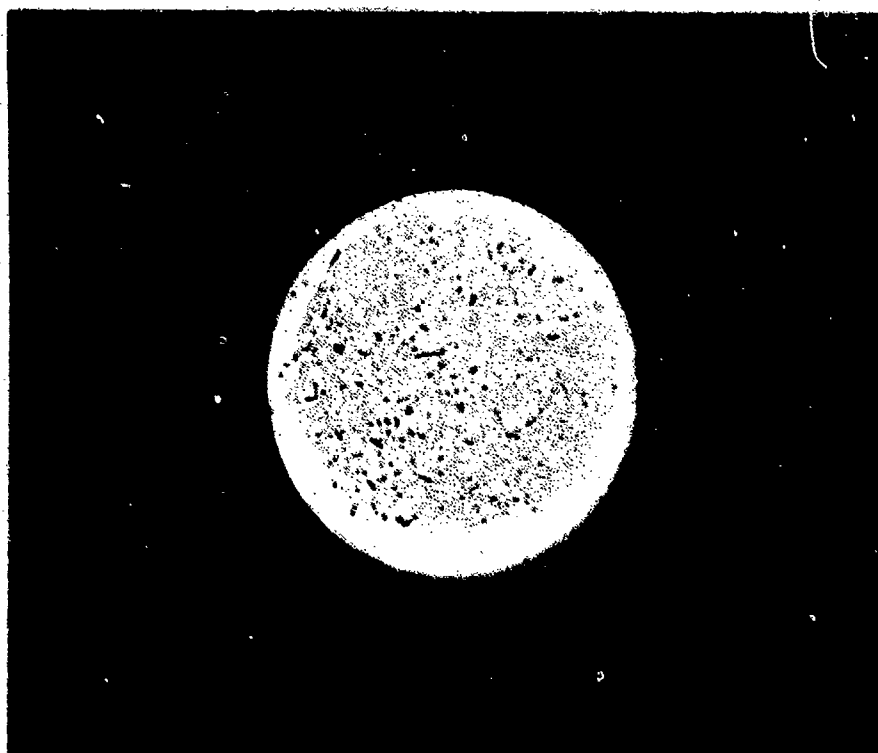
Particulate contamination on individual test articles could be identified as originating from deteriorated nearby materials on M0003 and other LDEF trays. Debris found on test articles flown in the canisters, particularly fibrous debris (Figure 40), may have come from the shuttle payload bay covers.

Figure 40. Debris contamination adhered to surface of 1.5 in. dia. silicone-based white paint test article exposed for 40 weeks in the TE (D8) canister
